Acute Metallosis Following Total Knee Replacement – A Case Report

Abstract

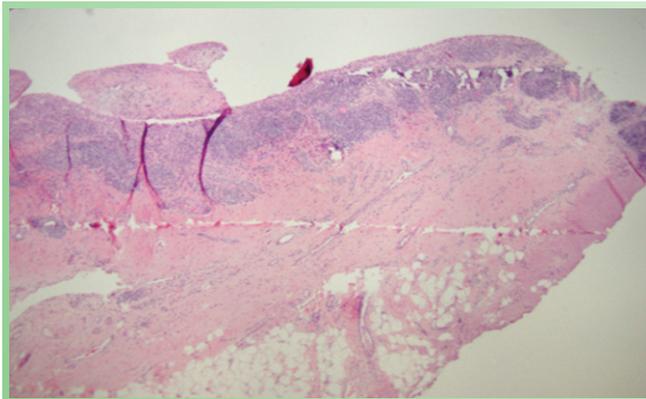
Figure 1: Lymphoid infiltrate and synovial lining cells in 59 year old male with acute-onset metallosis following total knee replacement (hematoxylin-eosin x100).

On pathologic examination, the synovium exhibited marked chronic inflammation and hyperplasia with extensive finely granular foreign material resembling metallic debris (Figs 1 and 2). Laboratory analysis of synovial tissue for iron, chromium, and cobalt demonstrated the presence of each metal at the following levels: iron (150 micrograms/gram), chromium (17 micrograms/gram), and cobalt (14 micrograms/gram). Although reference ranges for these metals in synovium are not established, normal tissue levels of chromium and cobalt should be undetectable; iron would be detectable in tissue with hemorrhage, but the synovium did not show evidence of significant hemorrhage.

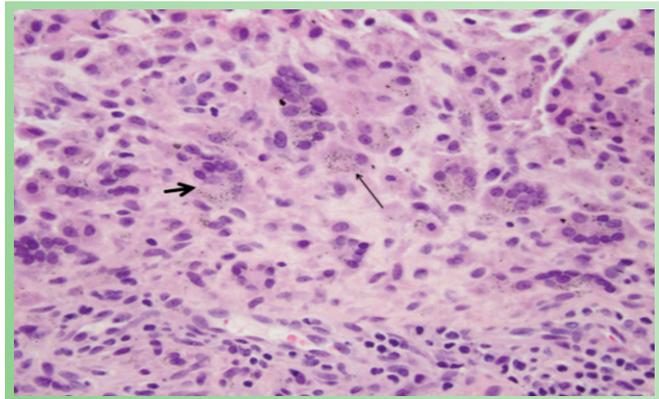
Figure 2: Intracellular metallic debris in synovial lining cells (thin arrow) and giant cells (thick arrow) in 59 year old male with acute-onset metallosis following total knee replacement (hematoxylin-eosin x 1000).

The novelty of the present case is the early onset of synovitis in a patient who exhibited pristine implants nine months after initial surgery. We believe metallosis developed acutely following deposition of iron from the three saw blades used during surgery, and that these fragments were not dislodged entirely by four liters of saline irrigation. A diagnosis of metallosis was supported by findings on pathology of finely granular foreign material resembling metallic debris in the synovium, and on laboratory analysis, the principal metal detected was iron.

Recognizing that bone cutting blades may differ in hardness, we believe it is important that surgeons have ready access to comparative ratings of blades in terms of hardness. Such information may inform surgeons in their choice of blades prior to, or even during, surgery should they encounter patients with unusually dense bone, mitigating, thereby, the need for multiple blades with the consequent risk of irretrievable debris deposition.
